GEND-INF- 074

TMI-2 CORE CAVITY SIDES AND FLOOR EXAMINATIONS

DECEMBER 1985 AND JANUARY 1986

M. L. Russell

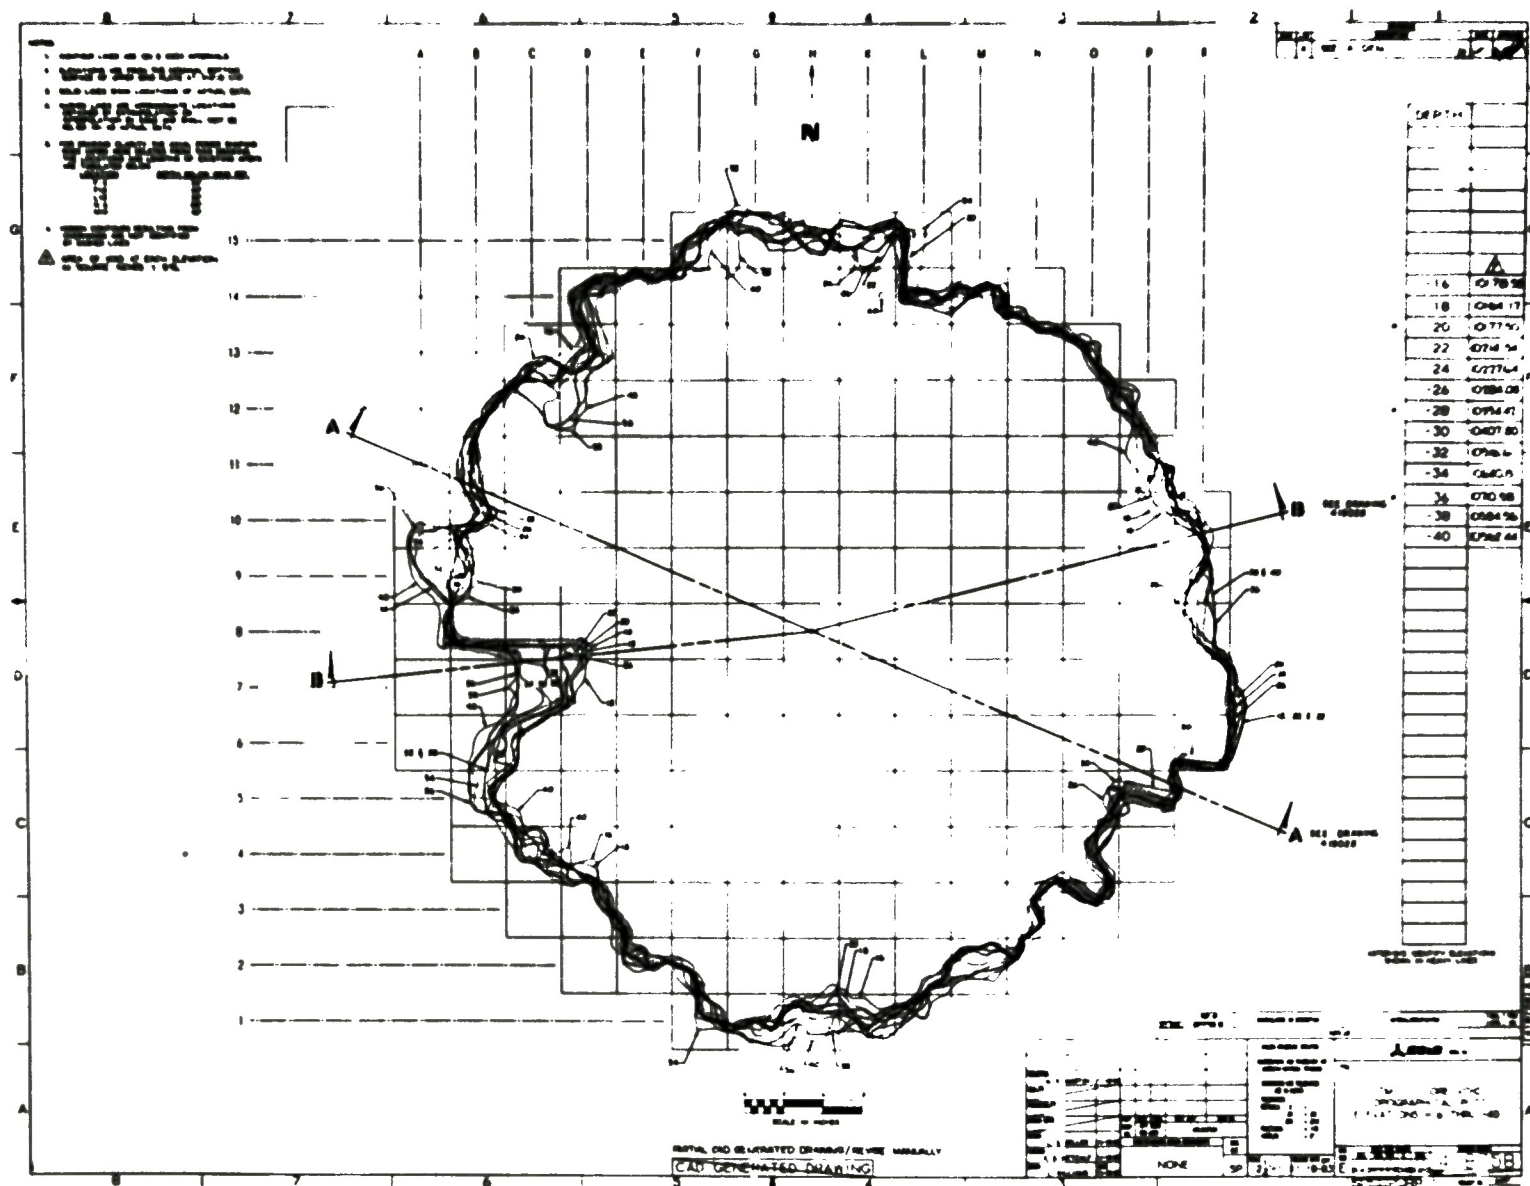
- o The cavity extended from the upper grid-plate bottom downward to approximately 7.5 ft above the core bottom and radially to the core former wall in some places
- o The core cavity volume was equivalent to approximately 26% of the original core region
- o Fuel assembly remnants appeared to encircle the core cavity completely toward the upper grid plate; the maximum fuel assembly damage appeared to be on the core East side, and the least fuel assembly damage on the core West side
- o The APSRs that had been inserted projected from the cavity ceiling and interfered with ultrasonic-scanner measurement of topography in the cavity upper regions.

Figure 8. TMI-2 core void topographical plot elevations -16 through -40.

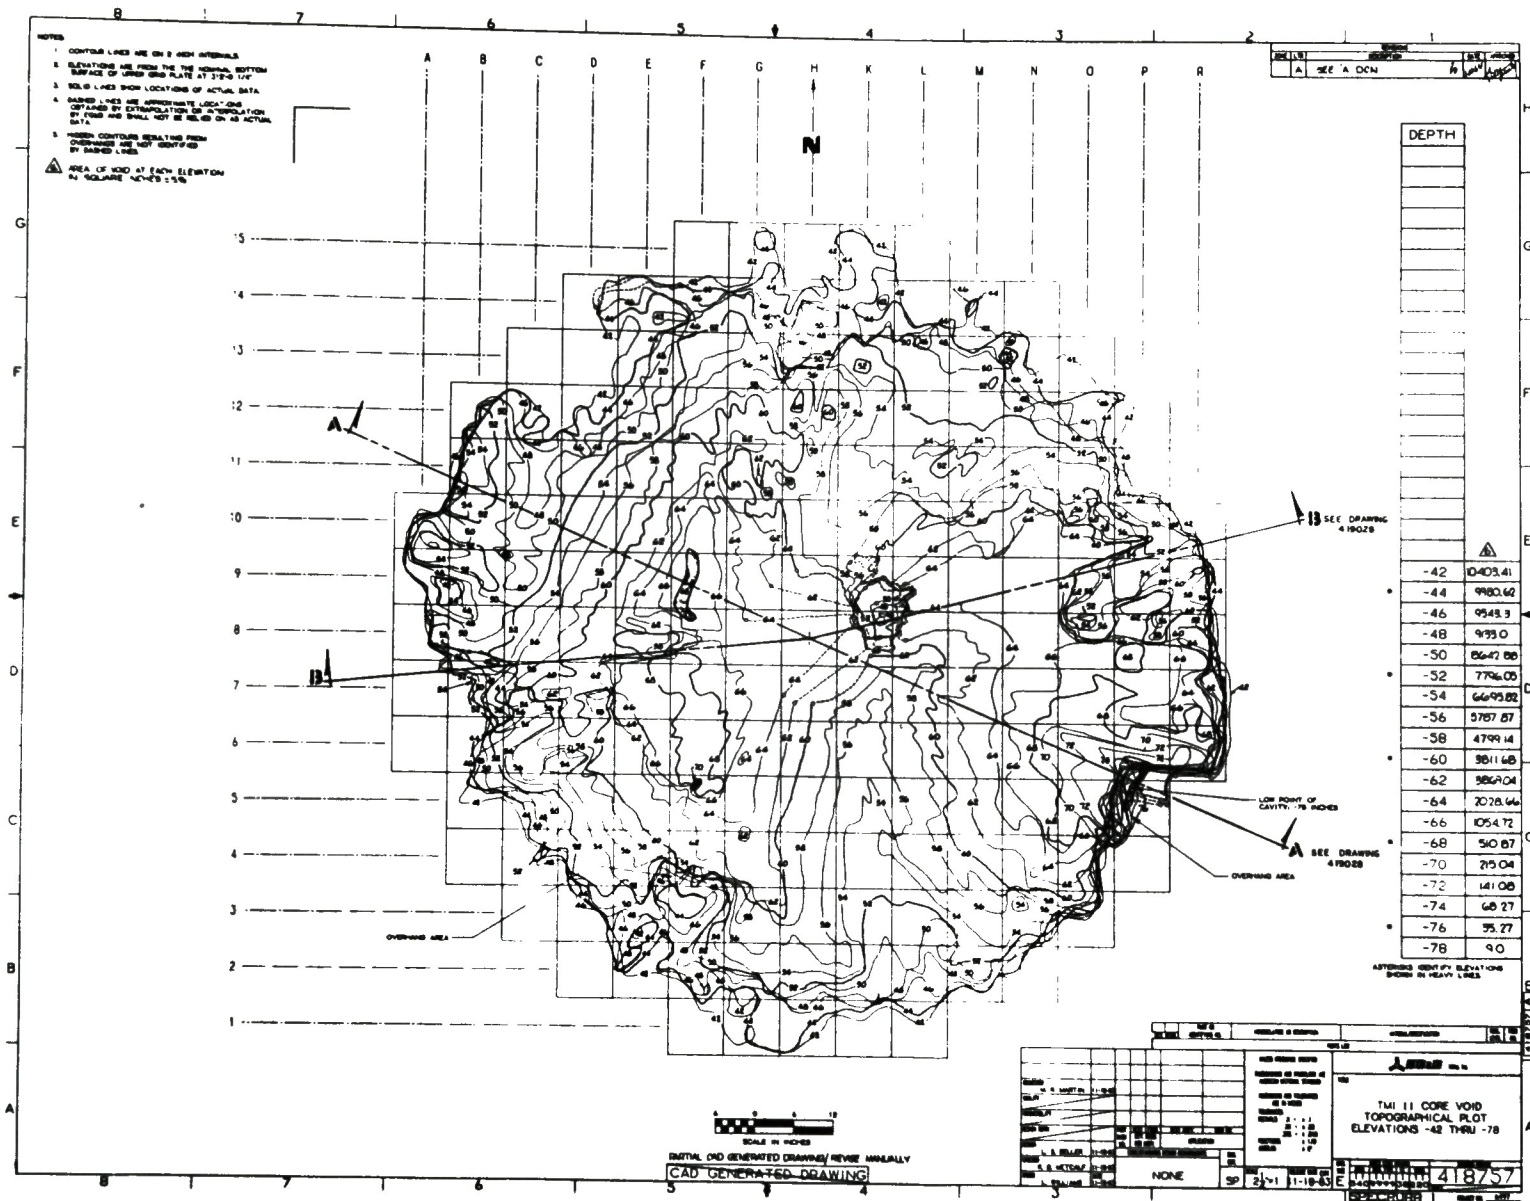
Figure 9. TMI-2 core void topographical plot elevations -42 through -78.

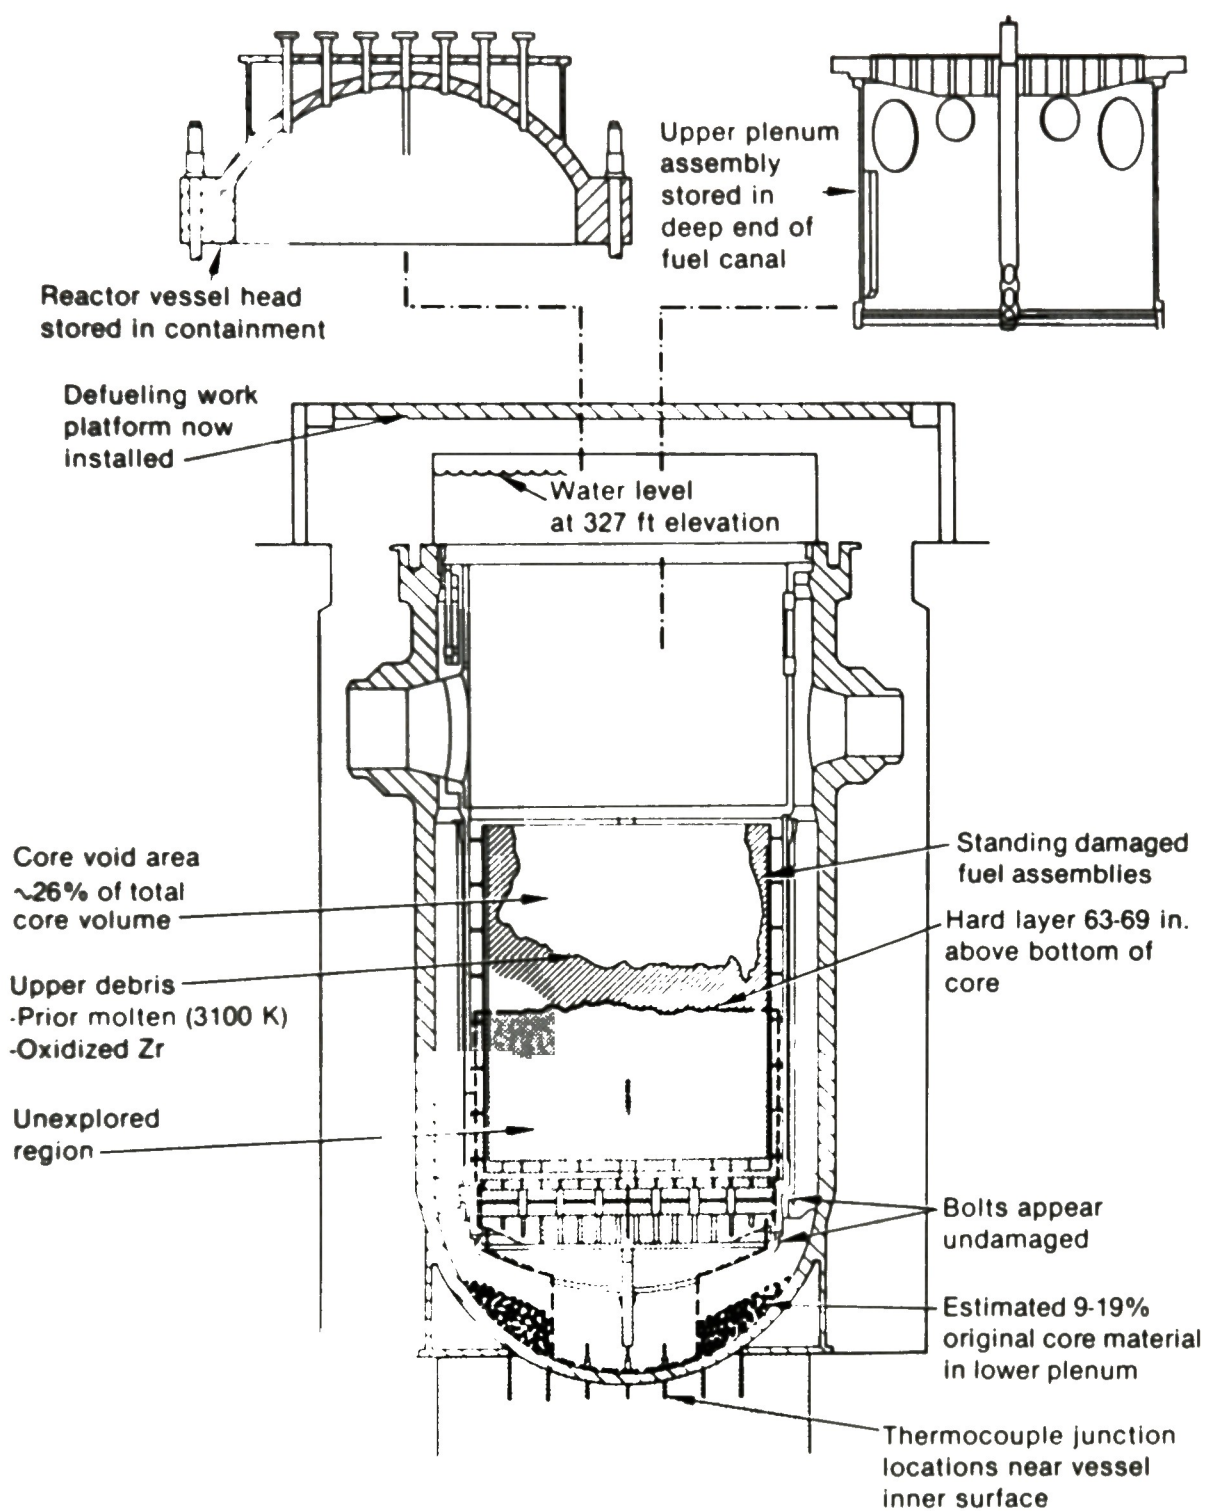
Figure 11. Reactor vessel conditions--December 1985.

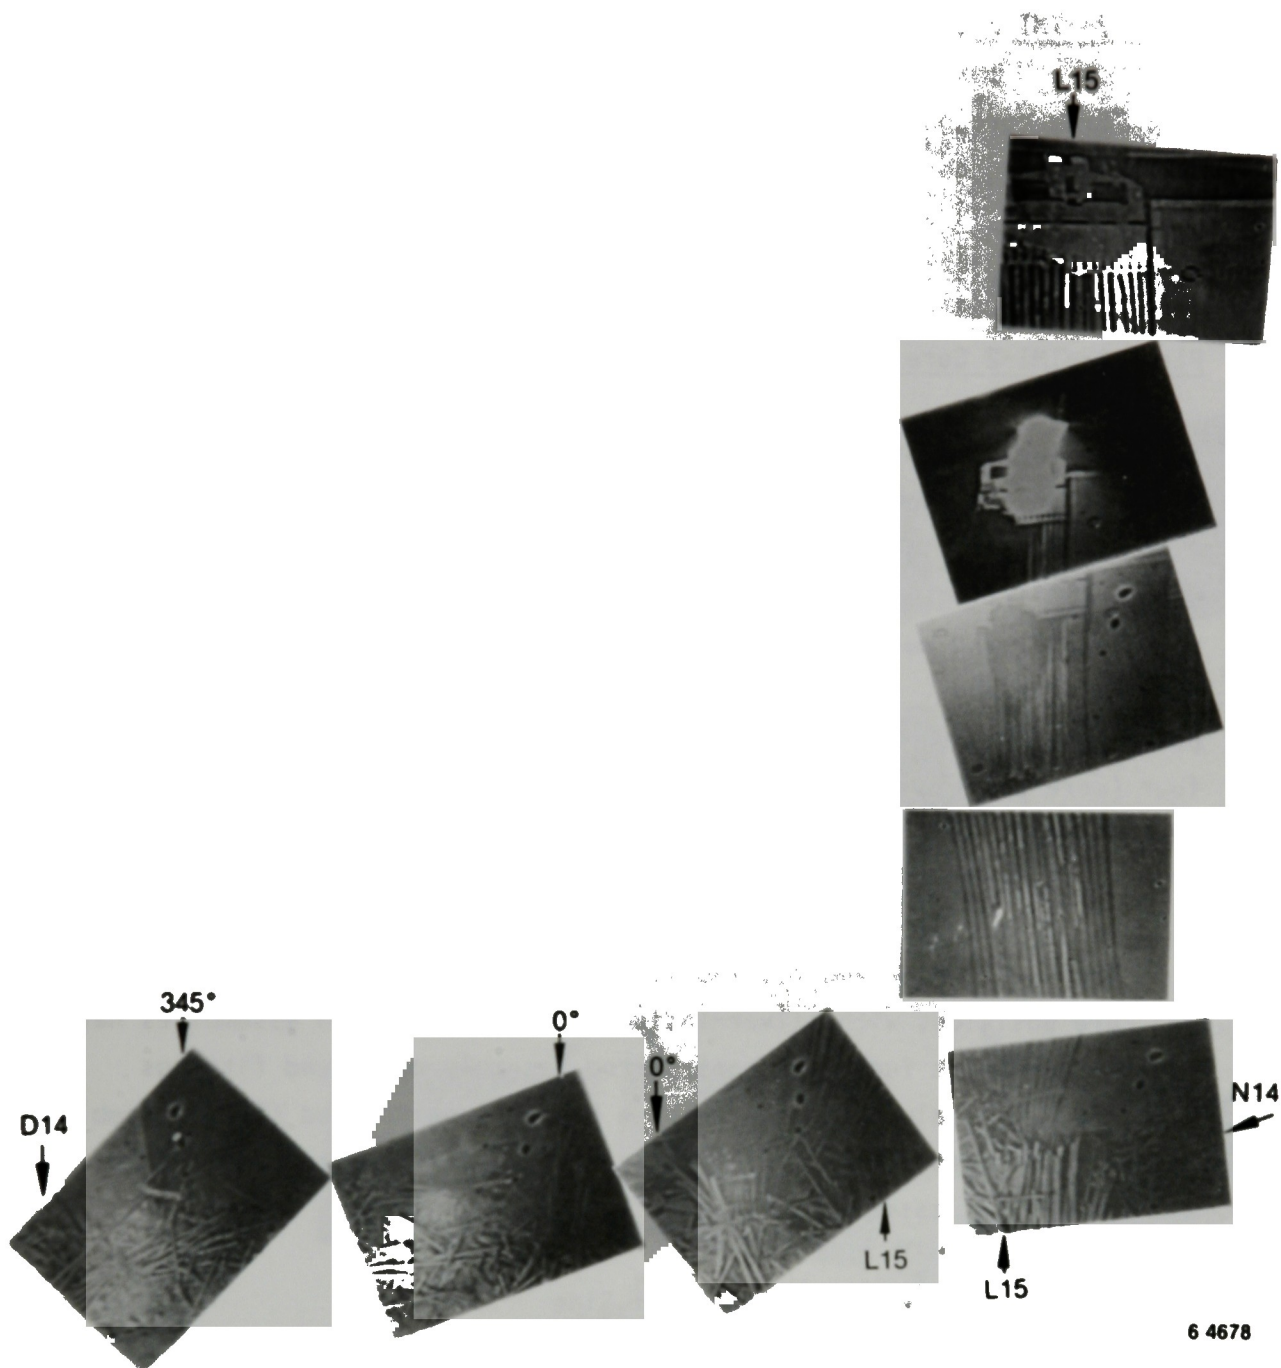
The damaged fuel assembly at core position L15 is the only fuel assembly still standing on the North Side. The upper end fitting and fuel bundle damage is consistent with the damage patterns observed on symmetrically located fuel assemblies.

Plate 1. TMI-2 core cavity north side--December 6 through 21, 1985 core position L15 fuel assembly.

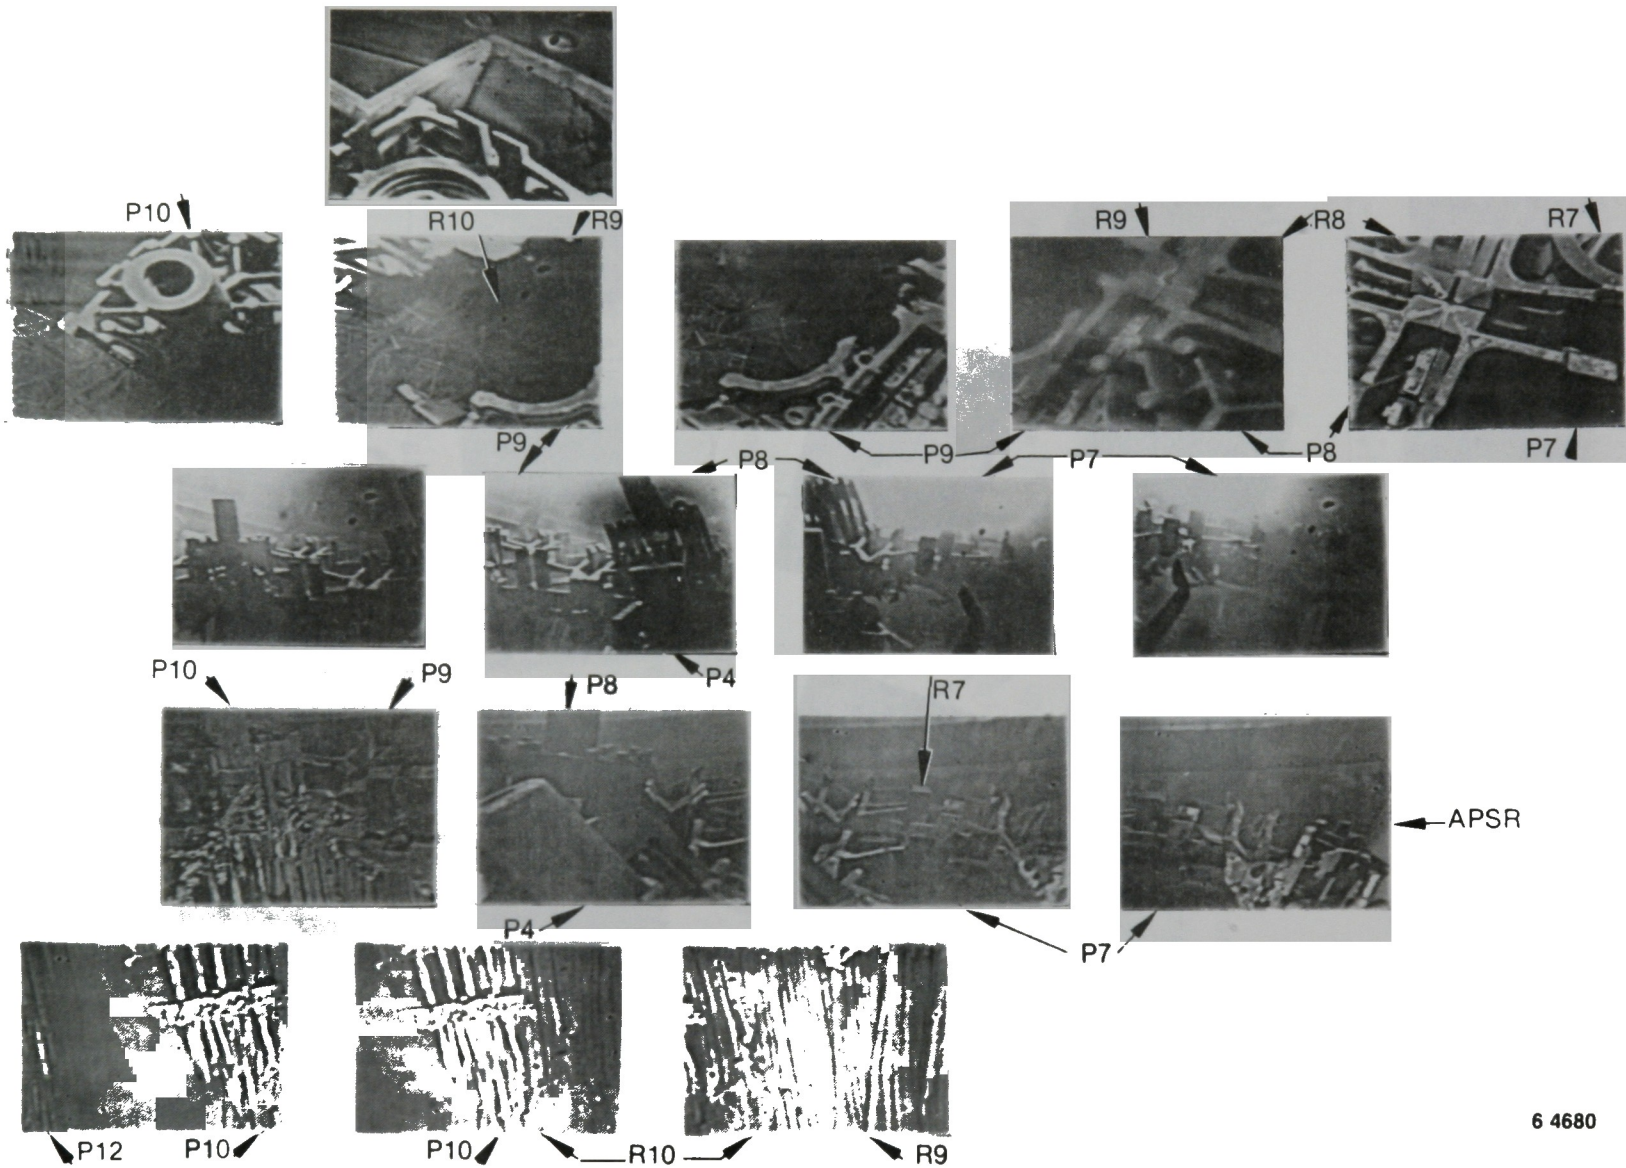
The Row P upper end fittings are of special interest. Both (P10 and P8) core positions with silver-indium-cadmium poison rod assemblies have relatively intact fuel- and control-rod assembly upper end fittings compared to the alumina-boron-carbide burnable poison rod (BPR) assemblies at core positions P9 and P7, which have completely missing BPR assemblies and gutted fuel assembly upper end fittings.

Plate 3. TMI-2 core cavity east side--December 6 through 21, 1985
core position P10, P9, P8, P7, R10, R9, R8, and R7 fuel
assemblies.

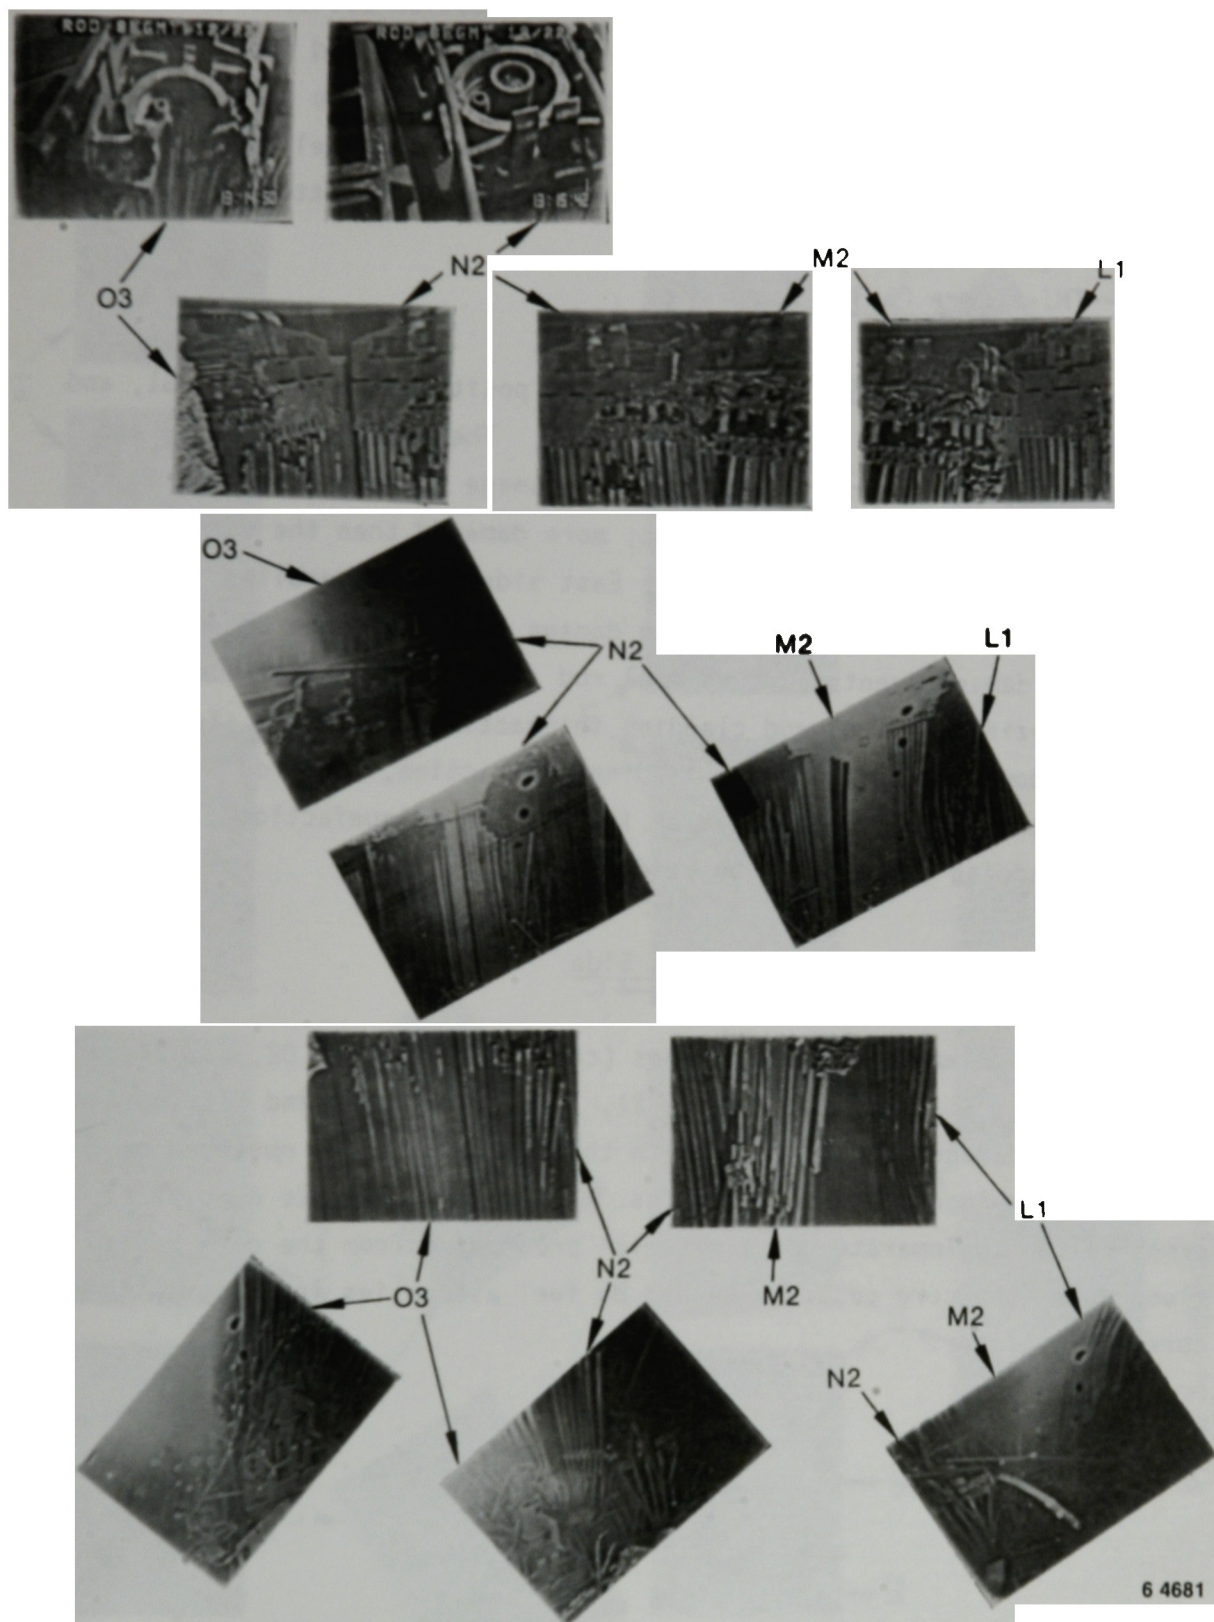
Four damaged fuel assemblies were still standing at core positions P4, O3, N2, and M2 on December 6, 1985, although the P4 core position fuel assembly was leaning into the East side field of view. The M2 core position fuel assembly toppled over before the December 21, 1985, video survey leaving three fuel rods still standing, but leaning inwards. The upper end fitting and fuel bundle damage are consistent with the damage patterns observed on symmetrically located fuel assemblies.

Plate 4. TMI-2 core cavity southeast side--December 6 through 22, 1985 core position O3, N2, and M2 fuel assemblies.

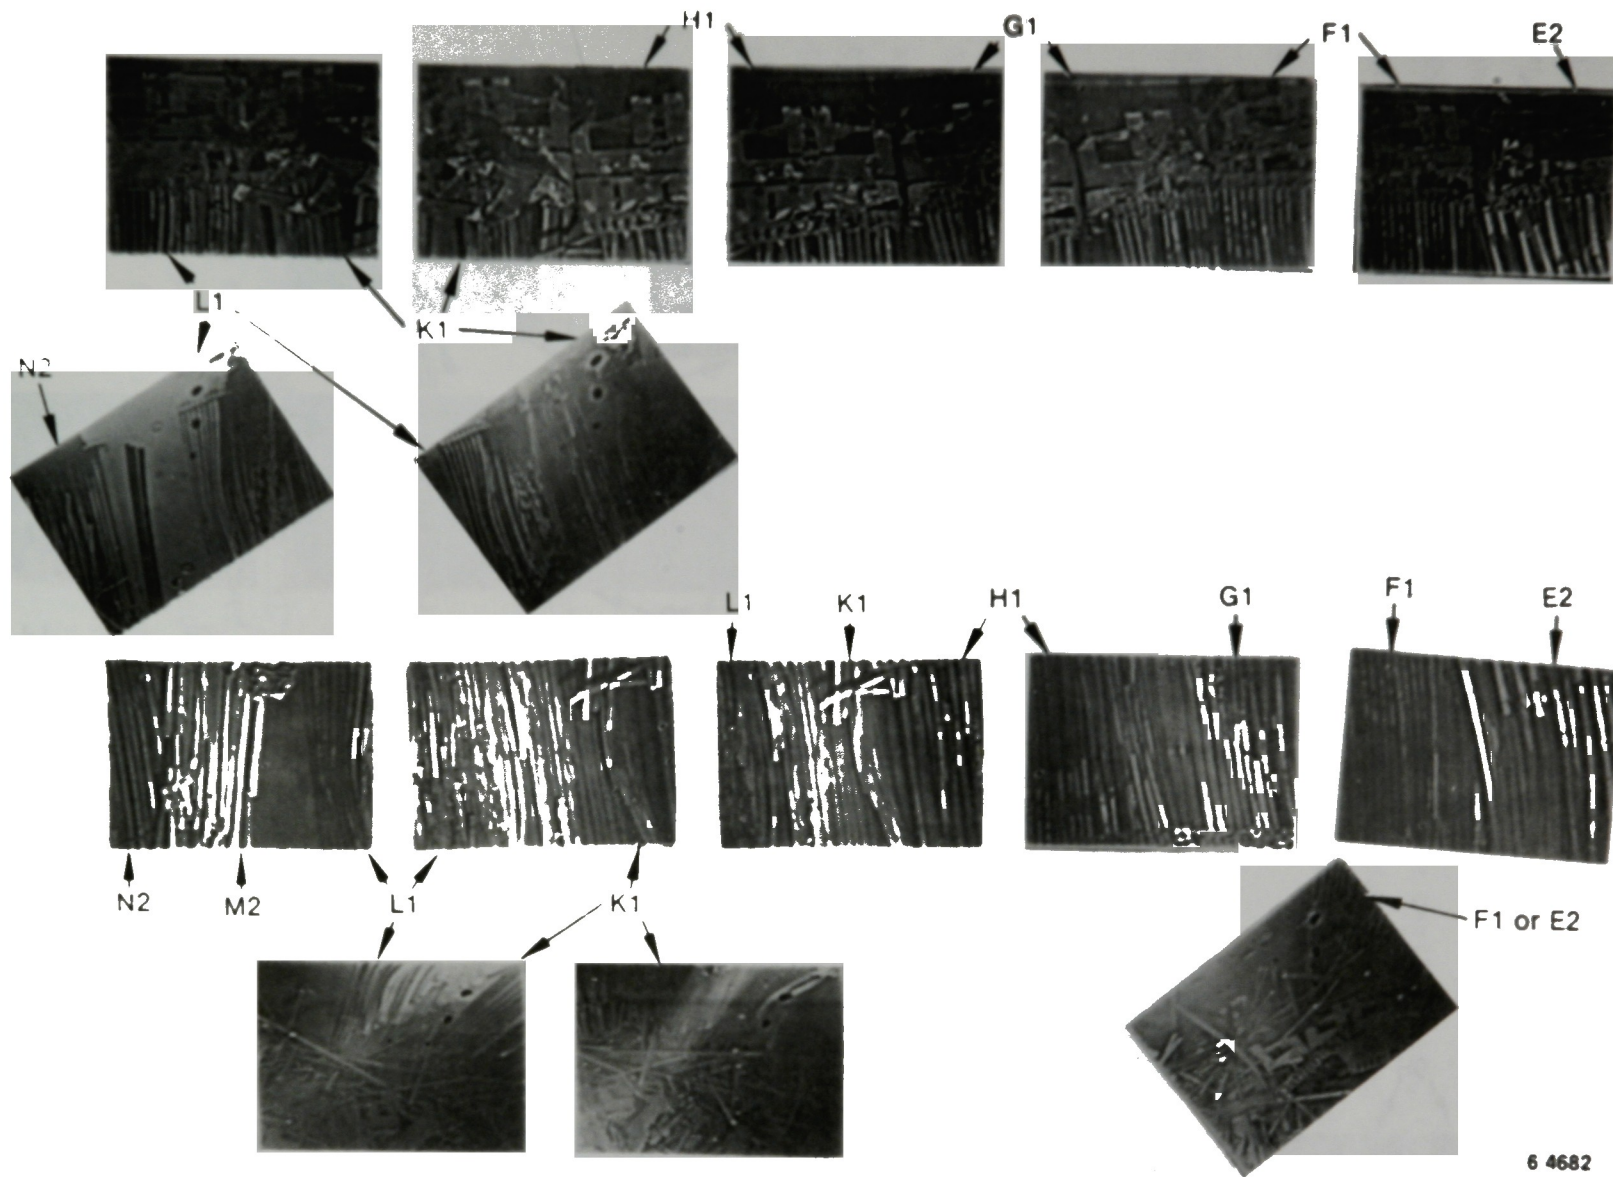
The five damaged fuel assemblies (core positions L1, K1, H1, G1, and F1) were still standing on December 6, 1985. The upper end fitting and fuel bundle damage is consistent with the damage patterns observed on symmetrically located fuel assemblies; more damaged than the West side fuel assemblies, and less damaged than the East side fuel assemblies. The core position L1 fuel assembly fuel bundle damage shows evidence of a variety of severe fuel damage events such as fuel rod swelling and burst, Inconel spacer grid-zircaloy fuel rod cladding interaction, stainless steel fuel pellet hold-down spring-fuel rod cladding interaction, fuel rod cladding-uranium dioxide fuel pellet interaction (liquefaction), and zircaloy cladding and guide tube oxidation.

Plate 5. TMI-2 core cavity south side--December 6 through 21, 1985
core position L1, K1, H1, G1, and F1 fuel assemblies.

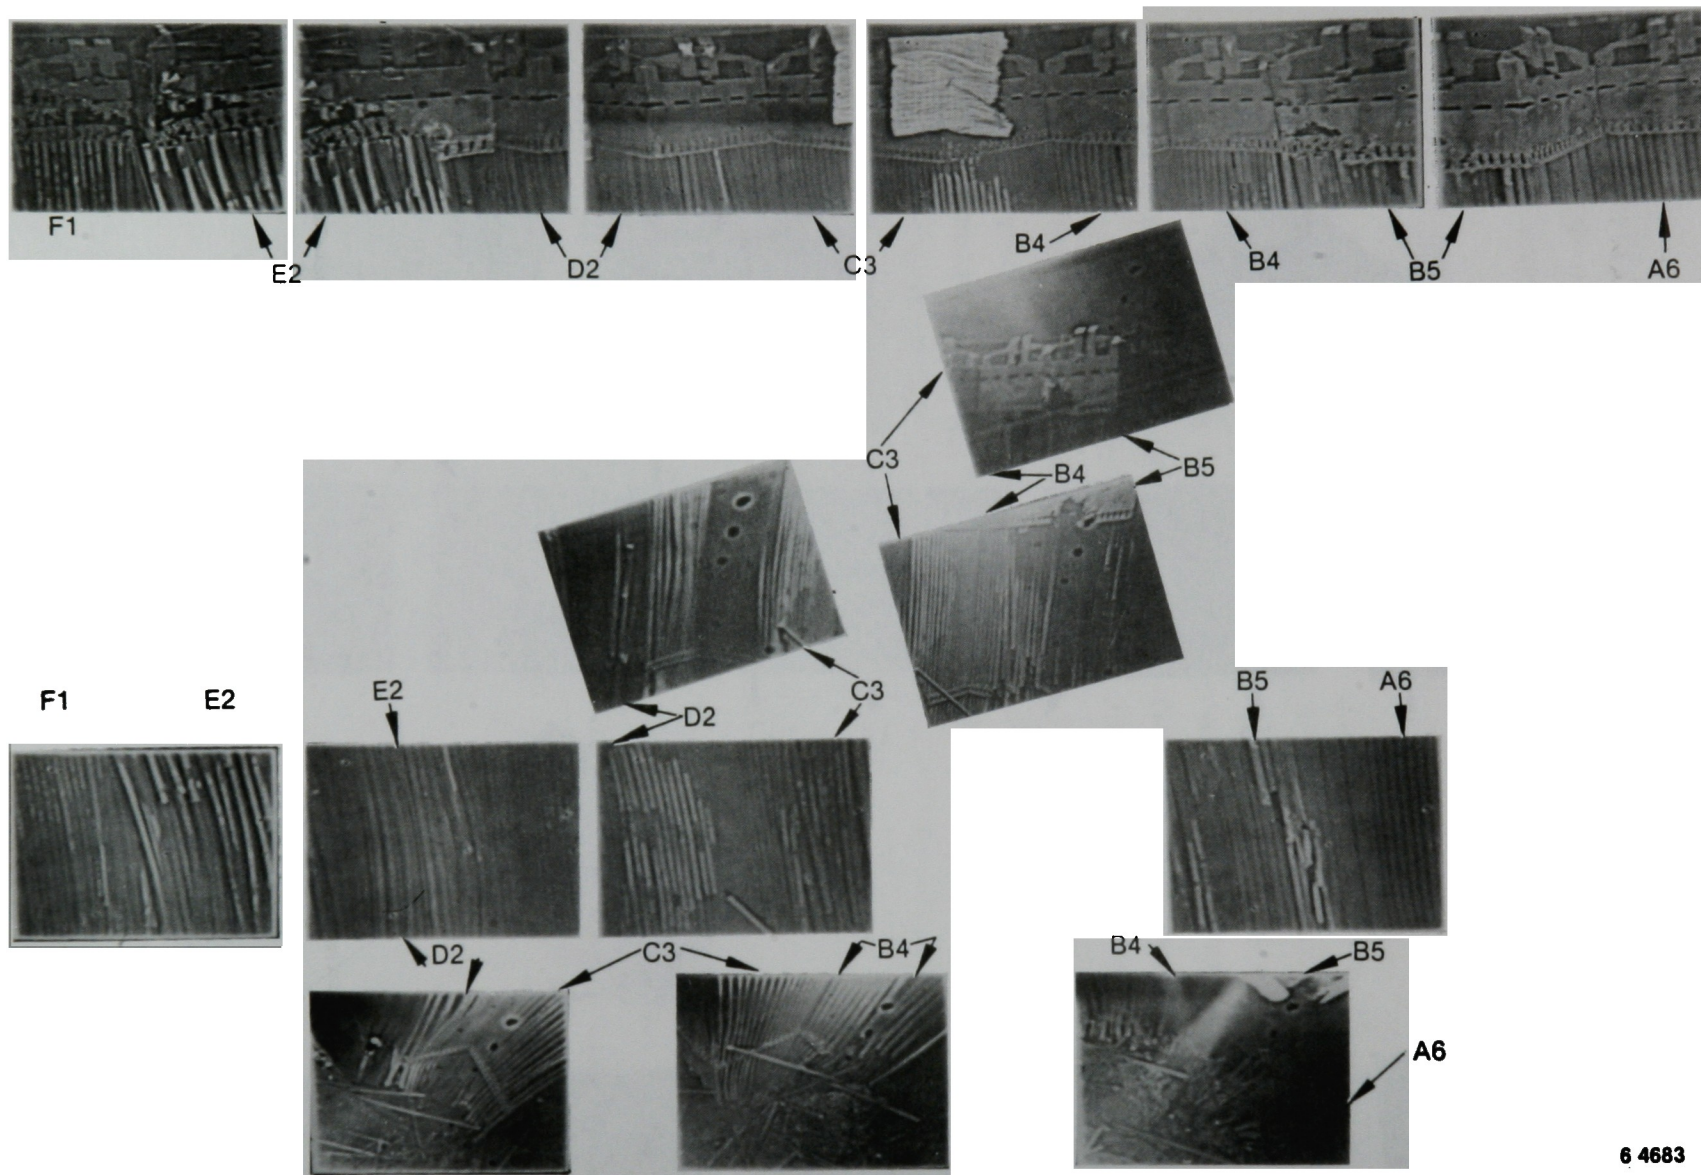
The five damaged fuel assemblies (core positions E2, D2, C3, B4, and B5) were still standing on December 21, 1985. The upper end fitting and fuel bundle damage is consistent with the damage patterns observed on symmetrically located fuel assemblies. There is a possible deposit of prior-molten agglomerated core material protruding from the core cavity floor where the core position B4 and B5 fuel assemblies intersect with the core cavity floor.

Plate 6. TMI-2 core cavity southwest side--December 6 through 21, 1985
core position E2, D2, C3, B4, and B5 fuel assemblies.

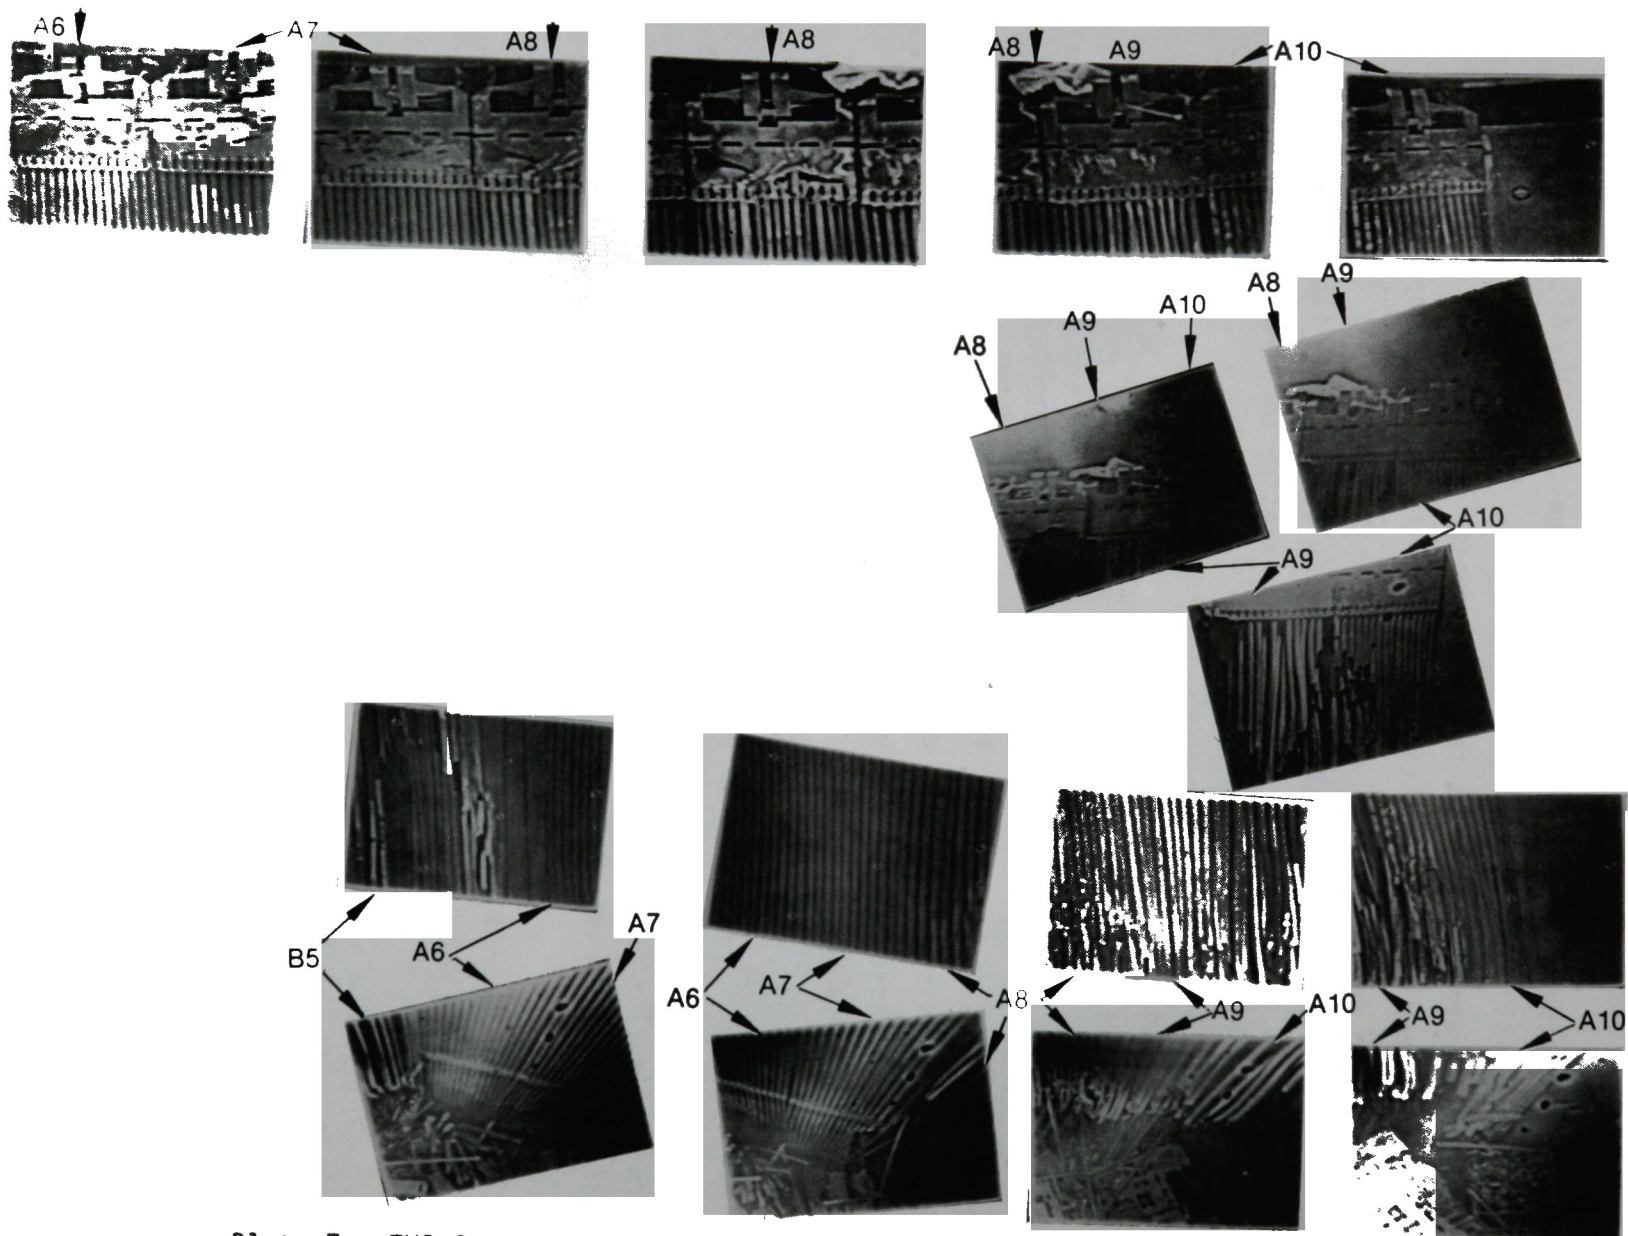
The five damaged fuel assemblies (core positions A6, A7, A8, A9, and A10) were still standing on December 21, 1985. The upper end fitting and fuel bundle damage represents the least damage of any of the eight sides and ranges from the core position A6 fuel assembly, which appears to have some fuel rod damage (slightly bent) toward the core cavity floor, to the other four fuel assemblies, which have examples of damage (ablated upper end fittings and missing fuel rod regions) similar to other peripheral fuel assemblies.

Plate 7. TMI-2 core cavity west side--December 6 through 21, 1985
core position A6, A7, A8, A9, and A10 fuel assemblies.

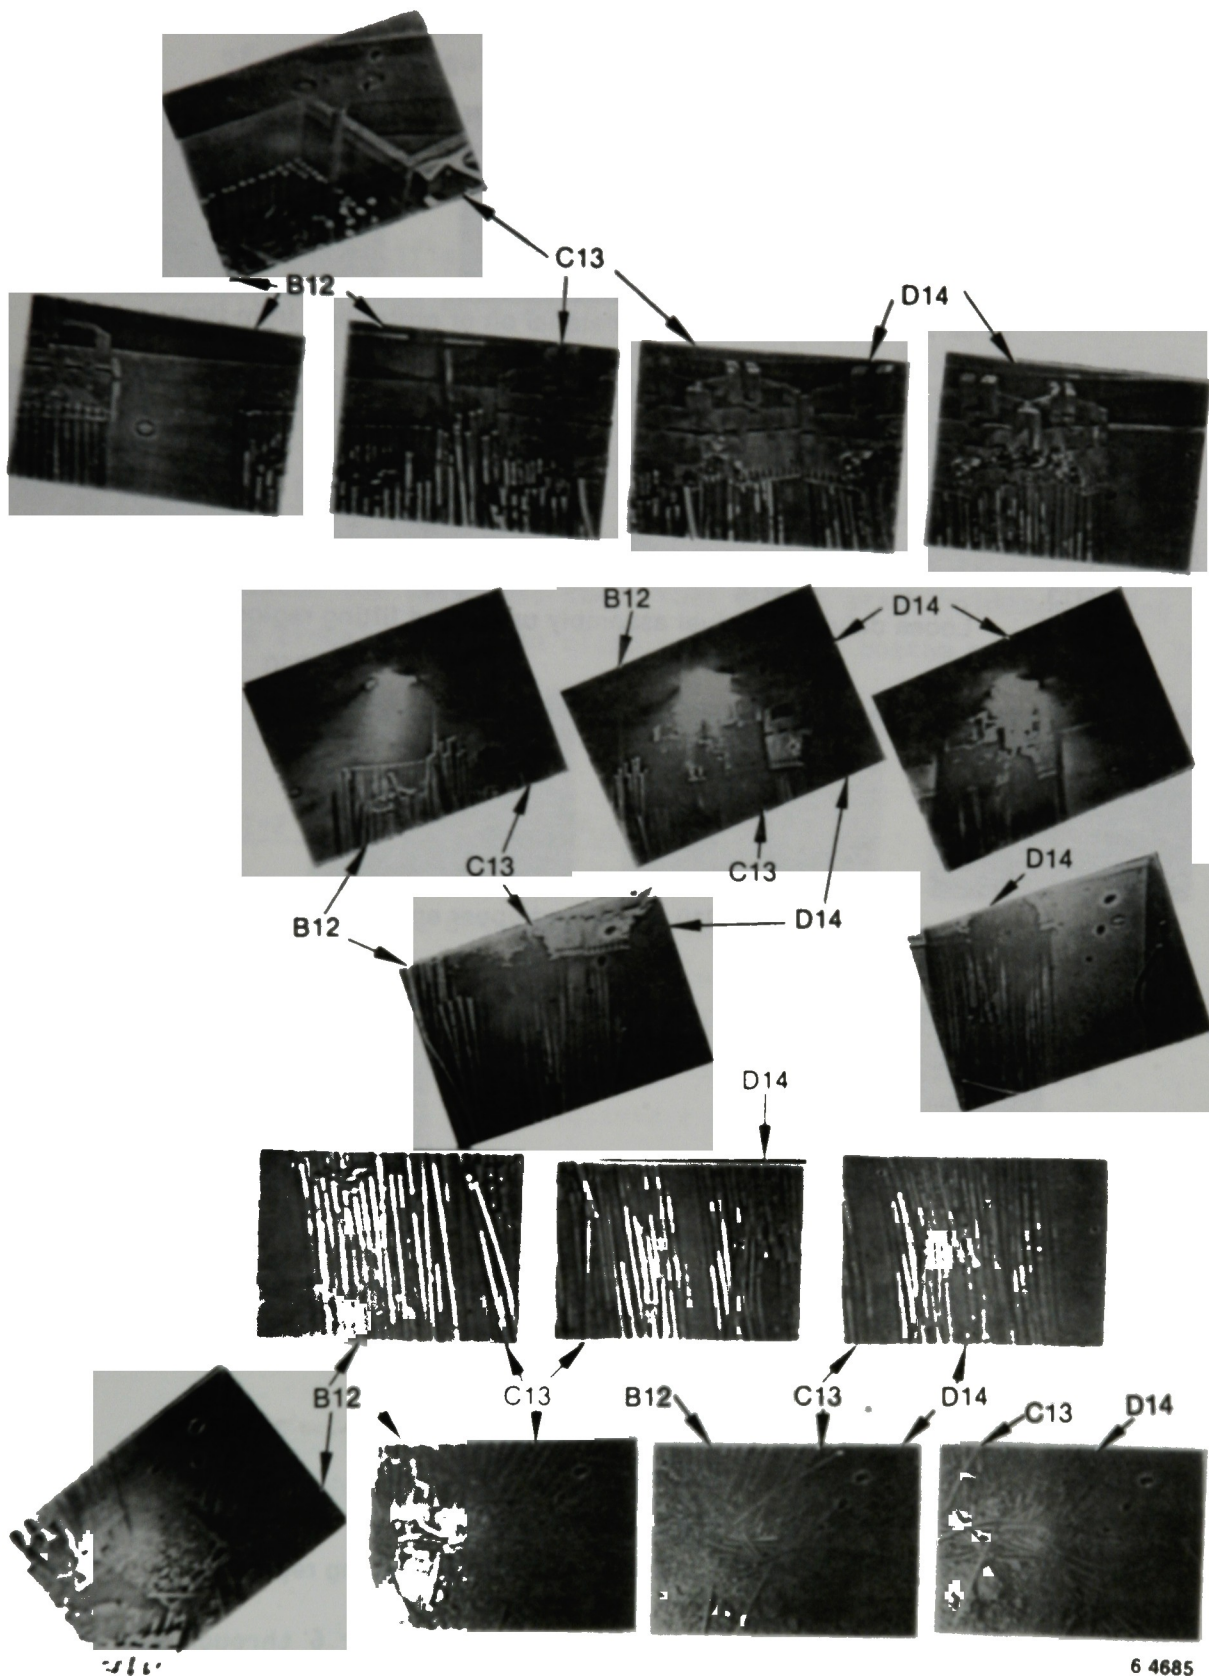
Three damaged fuel assemblies (core positions B12, C13, and D14) were still standing on December 6, 1985. The upper end fitting and fuel bundle damage is consistent with the damage patterns observed on symmetrically located fuel assemblies. The upper end fitting at core position B12 appears to have been separated from the fuel bundle by laterally pulling at the end fitting, which fractured the brittle fuel rods and guide tubes and left the more elastic fuel rods toward the core former intact. There is a possible deposit of prior-molten agglomerated core material protruding from the core cavity floor where the core position D14 fuel assembly intersects with the core-cavity floor.

Plate 8. TMI-2 core cavity northwest side--December 6 through 21, 1985 core position B12, C13, and D14 fuel assemblies.

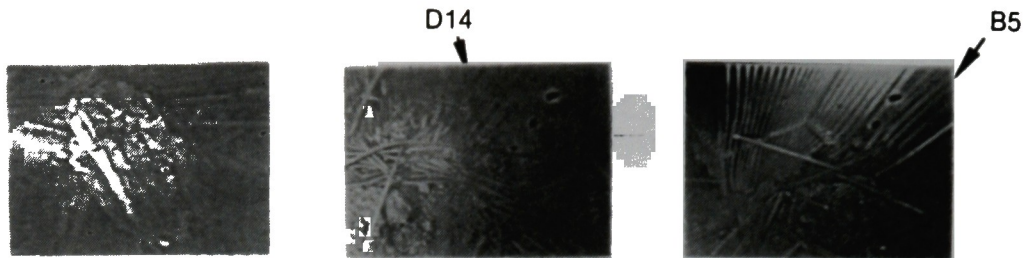
- o Agglomerated Core Material--Possible deposits of agglomerated core material were observed resting on or protruding through the core cavity floor. The rock-size piece resting on the top of fuel rod pieces appears to be decomposed fuel rods cemented together.

Rock size agglomerated core material on or protruding from floor

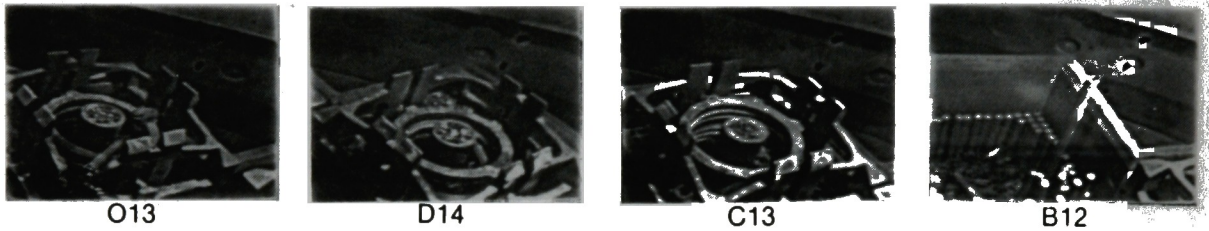
Loose debris on/in fuel assembly upper end fitting region

- o Loose Debris In Fuel Assembly Upper End Fitting Region--Deposits of small, irregular-shaped particles have collected on upward facing surfaces and cup-like areas of the fuel assembly upper rod fittings.
- o Other Identifiable Upper End Fittings--The damaged upper end fittings from core positions B10, C4, C5, D4, and D5 were identified during the video surveys in the loose debris on the core cavity floor.
- o Fuel Rod Damage in Pellet Stack Holddown Spring Region--A still-image photograph of fuel rod damage from interaction between the stainless steel fuel pellet stack holddown spring and the zircaloy fuel rod cladding is at the bottom of Plate 9. The fuel rod bundle section was lying on the core cavity floor; its original core location is unknown.

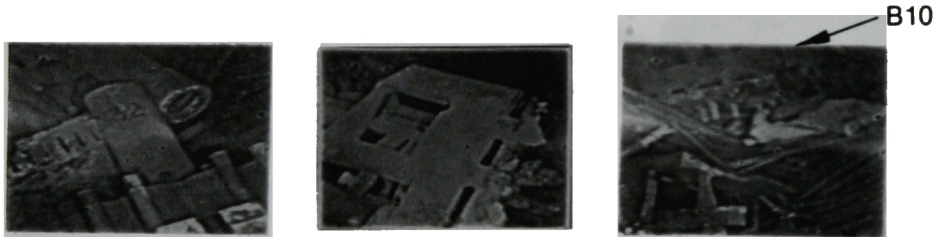
Core position B10 spider and upper end fitting

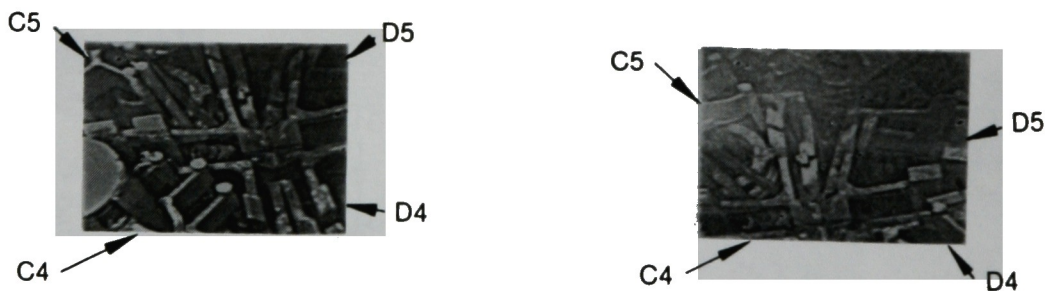
Core position C4, C5, D4 and D5 upper end fitting damage
